**Flood Control Project Maintenance
Levee Inspections**

Maintenance Issue Types Only, Levee Inspection Report By Mile - Spring 2018

Sacramento River West Side Levee District

Waterway	Bank	Unit Miles	Inspection Start/End	Inspector
Unit No. 01 Sacramento River	Right	49.64	03/21/2018 03/26/2018	Zach Jojola

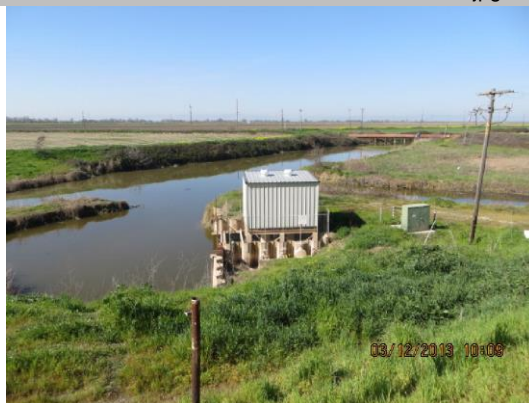
Photo 1 of 3 : UCIP_SP_2018_10087_17235.jpg

LM Start	0.14	Rating **	M	Issue No.	1551
LM End	0.14	Issue Type +	Ma	Location *	
Category	Supplemental			GPS Latitude/Longitude	
				Start	End
Item	DWR UCIP LMA Responsibility			38.801471 °	38.801471 °
				-121.725171 °	-121.725171 °
DWR ID					
Comment Code					
Inspector Comment					
FS_ID:10087 DS_ID:20224 EP_NO: N/A Repair Type: Non-Urgent Crossing Status: Found UCIP Comments: Headwall on WS undermined about 3-4-feet. FIELD_STRUCT_DESC: 1 of 3: 36-inch steel drainage pipe through the levee, 30.0 feet below the crown. Flap gate on the waterside (WS) end. 24-inch pipe sleeved through the 36-inch pipe. Annular space between pipes grouted. Pumps in pump house with walkway on landside (LS) toe. [Additional Reference(s): DWR Levee Log, 2006. USACE Sacramento O&M Manual 130, May 1960 (HLM 0.15)]. FS Date: 3/12/2013

Pumphouse at LS toe.

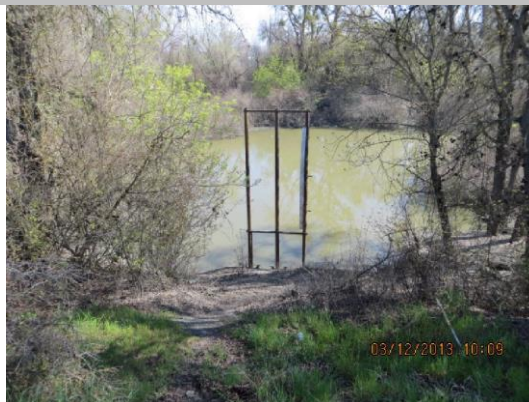
Photo 2 of 3 : UCIP_SP_2018_10087_17234.jpg

Air vents at outlet on WS toe.

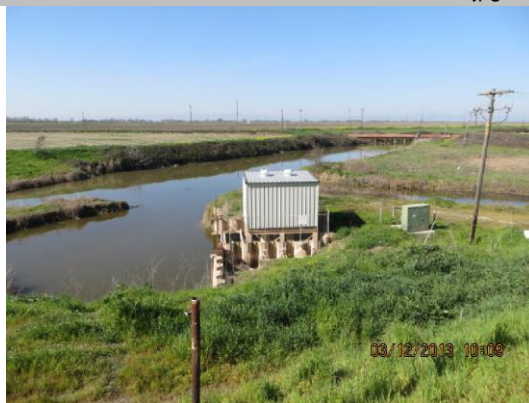
Photo 1 of 3 : UCIP_SP_2018_10910_18185.jpg

LM Start	0.14	Rating **	M	Issue No.	1553
LM End	0.14	Issue Type +	Ma	Location *	
Category	Supplemental			GPS Latitude/Longitude	
				Start	End
Item	DWR UCIP LMA Responsibility			38.801491 °	38.801491 °
				-121.725184 °	-121.725184 °
DWR ID					
Comment Code					
Inspector Comment					
FS_ID:10910 DS_ID:20357 EP_NO: N/A Repair Type: Non-Urgent Crossing Status: Found UCIP Comments: Headwall undermined 3-4-feet on WS toe. FIELD_STRUCT_DESC: 3 of 3: 36-inch steel drainage pipe through the levee, 30 feet below the crown. Flap gate on the waterside (WS) end. 24-inch pipe sleeved through the 36-inch pipe. Annular space between pipes grouted. Pumps inside pump house with a walkway on the landside (LS) toe. [Additional Reference(s): DWR Levee Log, 2006. USACE Sacramento O&M Manual 130, May 1960 (HLM 0.15)]. FS Date: 3/12/2013

Pumphouse on LS toe.

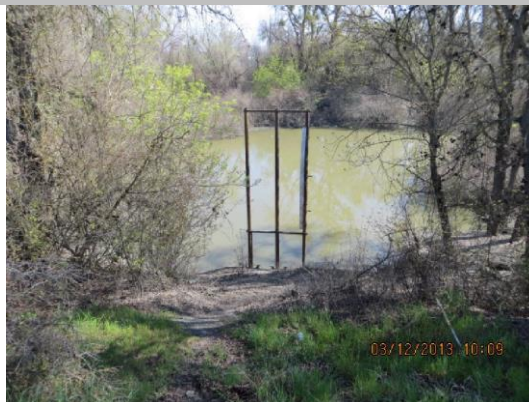
Photo 2 of 3 : UCIP_SP_2018_10910_18184.jpg

Air vents on pipes at WS toe.

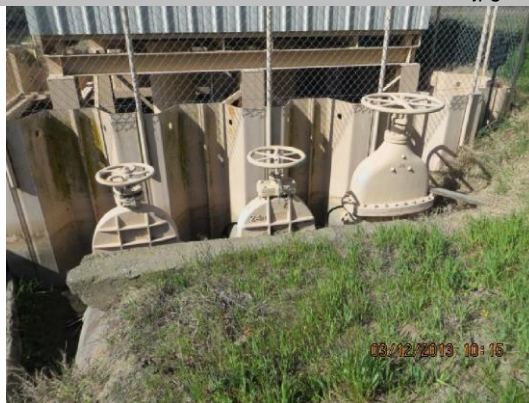
Photo 3 of 3 : UCIP_SP_2018_10910_18183.jpg

Slide gates at pumphouse on LS toe.

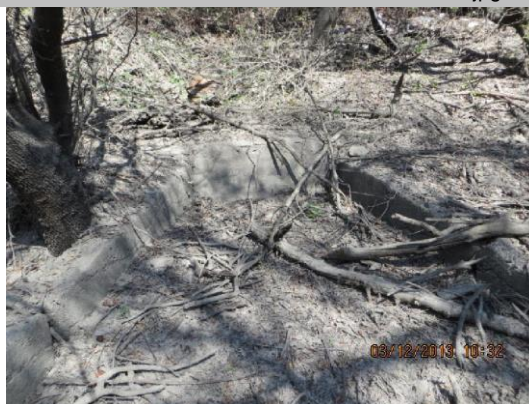
Photo 1 of 1 : UCIP_SP_2018_10088_17237.jpg

LM Start	0.22	Rating **	A/W	Issue No.	1554	
LM End	0.22	Issue Type +	Ma	Location *		
Category	Supplemental			GPS Latitude/Longitude		
				Start	End	
Item	DWR UCIP LMA Responsibility			38.802293 °	38.802293 °	
				-121.724847 °	-121.724847 °	
DWR ID						
Comment Code						
Inspector Comment						
FS_ID:10088						
DS_ID:20327						
EP_NO: N/A						
Repair Type: No Action Needed						
Crossing Status: Found						
UCIP Comments:						
FIELD_STRUCT_DESC: *ABANDONED* 42-inch drainage pipe of an unknown material through the levee, 28.5 feet below the crown.						
Abandoned in place by plugging with concrete. Headwall on waterside (WS) toe. [Additional Reference(s): USACE Sacramento O&M Manual 130, May 1960 (HLM 0.22)].						
FS Date: 3/12/2013

Concrete headwall visible on WS toe.

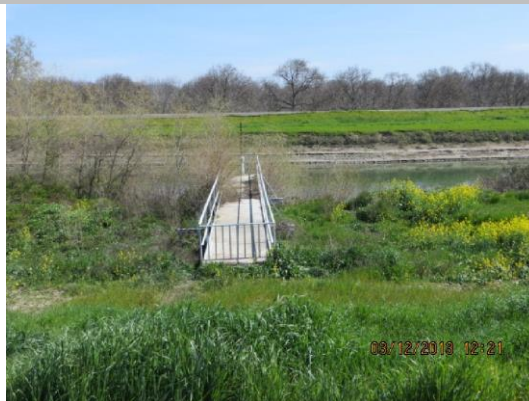
Photo 1 of 3 : UCIP_SP_2018_10125_17283.jpg

LM Start	3.54	Rating **	A/W	Issue No.	1556	
LM End	3.54	Issue Type +	Ma	Location *		
Category	Supplemental			GPS Latitude/Longitude		
				Start	End	
Item	DWR UCIP LMA Responsibility			38.846492 °	38.846492 °	
				-121.730066 °	-121.730066 °	
DWR ID						
Comment Code						
Inspector Comment						
FS_ID:10125						
DS_ID:20331						
EP_NO: N/A						
Repair Type: No Action Needed						
Crossing Status: Found						
UCIP Comments:						
FIELD_STRUCT_DESC: 5-foot by 5-foot reinforced concrete box drainage tunnel through the levee, 33 feet below the crown. Slide gate at outlet on the waterside (WS) toe. Tunnel runs from concrete U-shaped riser unit on the landside (LS) shoulder to the WS toe. Steel walkway to slide gate actuator on the WS berm. [Additional Reference(s): USACE Sacramento O&M Manual 130, May 1960 (HLM 3.59)].						
FS Date: 3/12/2013

Steel walkway on WS berm with Slide gate actuator.

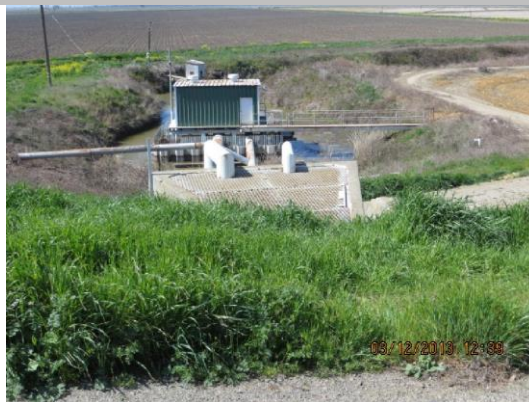
Photo 2 of 3 : UCIP_SP_2018_10125_17282.jpg

Pumphouse at LS toe and concrete riser on LS shoulder.

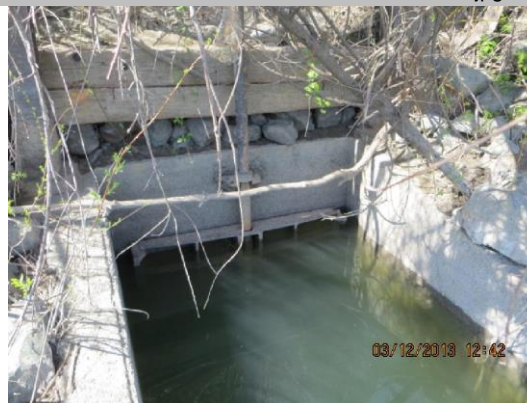
Photo 3 of 3 : UCIP_SP_2018_10125_17281.jpg

Slide gate at outlet at river side.

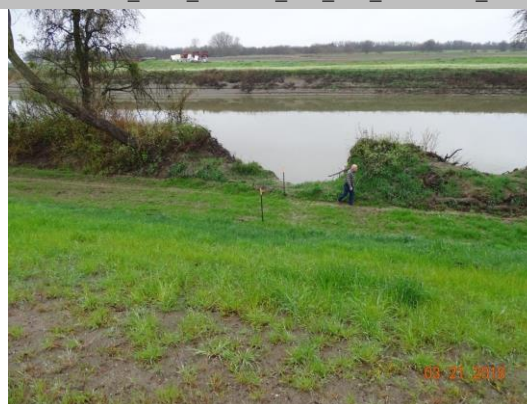
Photo 1 of 3 : SP_2018_NA0016_435_112_20180326_00250.jpg

LM Start	8.55	Rating **	A/W	Issue No.	112
LM End	8.55	Issue Type +	Ma	Location *	WS
Category	Earthen Levee			GPS Latitude/Longitude	
				Start	End
Item	Erosion / Bank Caving			38.857422 °	38.857422 °
				-121.780870 °	-121.780870 °
DWR ID	DWR_NA0016_01_s_2018_112				
Comment Code					
E1 : Note and monitor erosion site.					
Inspector Comment					
Location on waterside berm where oak tree fell and removed soil around the roots. There is a bend in the river at this location and has to potential to erode. Recommend monitoring.

View of the berm where the oak tree used to stand, facing the Sacramento River. Spring 2018.

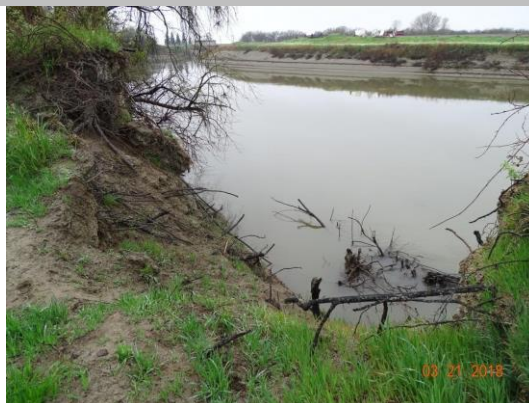
Photo 2 of 3 : SP_2018_NA0016_435_112_20180326_00251.jpg

View of the remaining roots, facing upstream. Spring 2018.

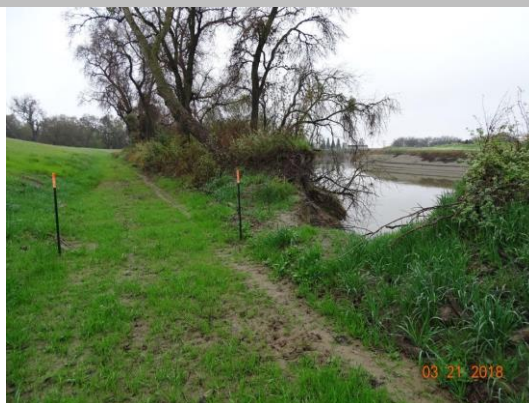
Photo 3 of 3 : SP_2018_NA0016_435_112_20180326_00252.jpg

Additional view of the berm. Spring 2018.

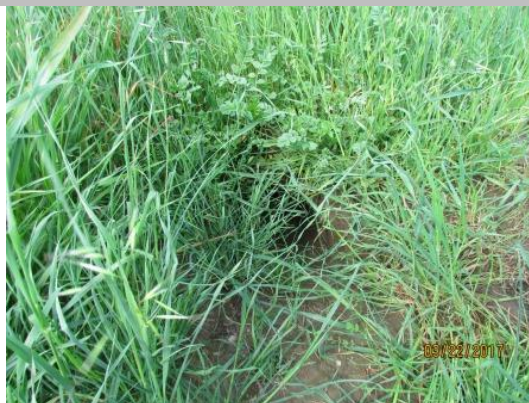
Photo 2 of 2 : SP_2018_NA0016_435_233_20180306_00080.jpg

Rodent burrow on landside levee slope. Spring 2017.

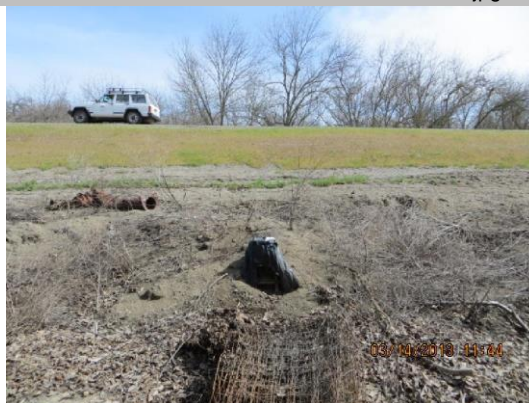
Photo 1 of 3 : UCIP_SP_2018_10291_17548.jpg

Gate valve buried on LS toe.

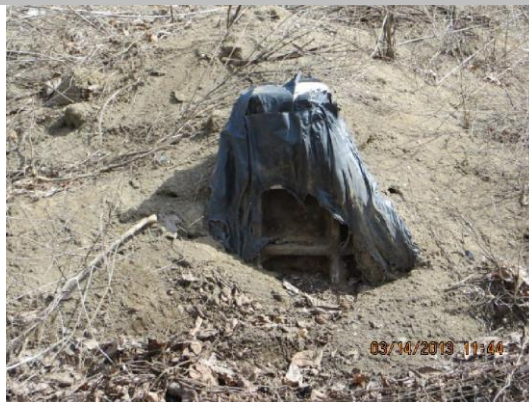
Photo 2 of 3 : UCIP_SP_2018_10291_17547.jpg

Gate valve buried on LS toe.

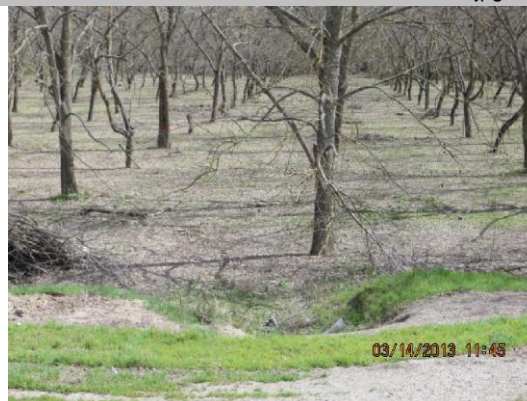
Photo 3 of 3 : UCIP_SP_2018_10291_17546.jpg

Excavation at WS toe where pipe should be.

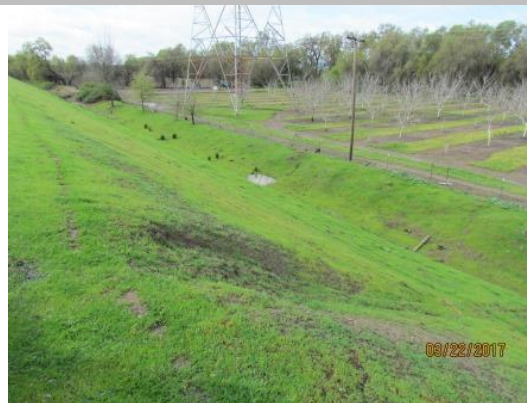
Photo 1 of 2 : SP_2018_NA0016_435_146_20180306_00070.jpg

Slope stability issue due to foot traffic. Spring 2017.
